An Assessment of the Severity of a Metal Loss Defect Detected on the Steam Boiler Drum of a Thermoelectric Power Plant and the Development of a Repair Technology

Gheorghe Dumitru, Gheorghe Zecheru

Universitatea Petrol – Gaze din Ploiești, Bd. București, 39, Ploiești
e-mail: dgheorghe@upg-ploiesti.ro, gzecheru@upg-ploiesti.ro

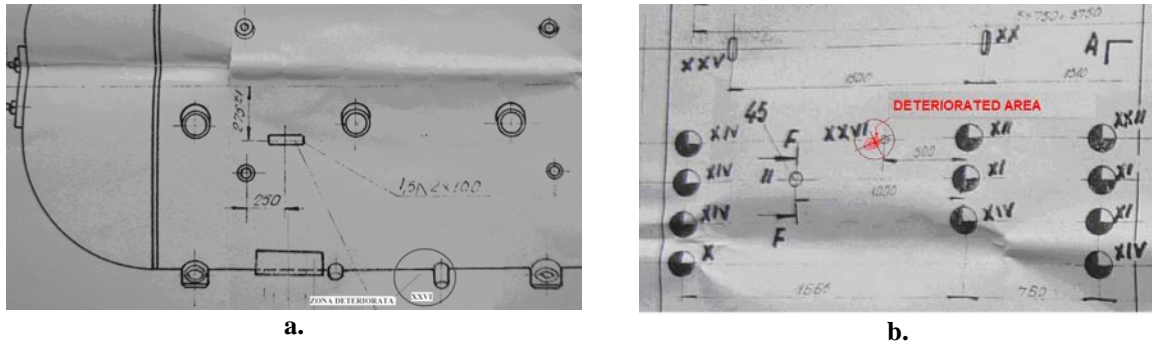
The defect was discovered during an accidental boiler shutdown. Careful inspection of the boiler drum revealed a crack that had penetrated the weld on the exterior plug of a pipe connector. The damaged test connector Dn20, denoted by XXVI Ø25x20x4 on the blueprints in figure 1, is located at 600 mm from the saddle-type support and at 500 mm from the pool of input/output pipe connectors labelled XI, XII, XIV, 3Ø133x20x4. The geometry of a suitable region enclosing the defect and relevant neighbouring elements on the drum mantle is presented in Figures 1 and 2.

Fig. 1. The positioning of the deteriorated area: a. in section with longitudinal view; b. drum unfolded image with a view from outside according to the project in the deteriorated area

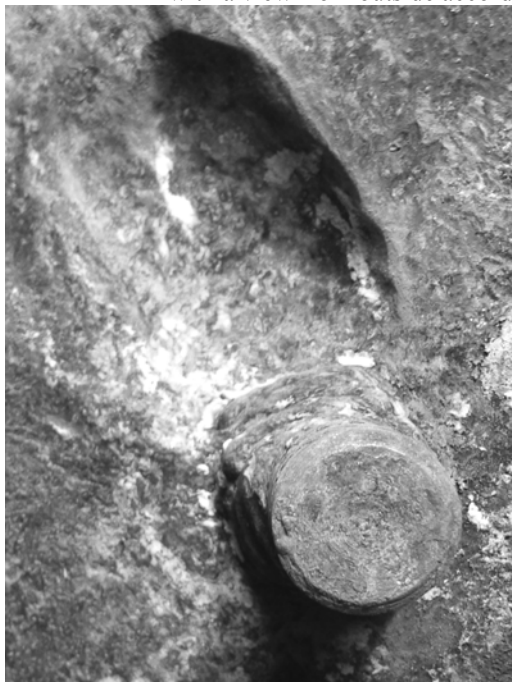
Fig. 2. Processing of the photo outlines

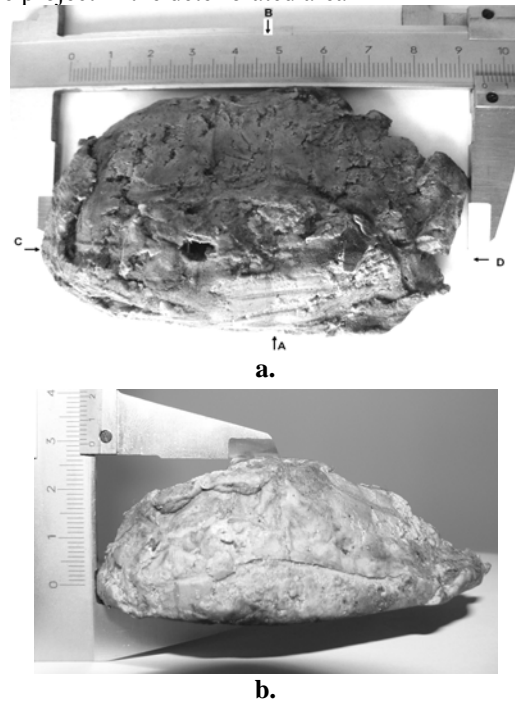
time, through erosion, a loss of material defect on the outer surface of the drum. The shape and size of the material loss are determined by photometric analysis of a cast, sampled at the site, as presented in Figures 3. The defect is elliptical in shape (Figure 3a), extending longitudinally over $s_p = 95.2$ mm (defined as the defect length) and transversely over $c_p = 62$ mm (the defect width). The maximum depth of the loss of material, as measured on the cast in Figure 3b, is $d_{max} = 33$ mm.

Fig. 3. Cast projection: a. on a horizontal plane; b. on a vertical plane, lateral view from A

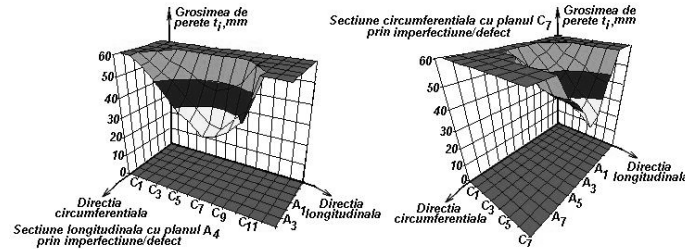
It has been found that the first two criteria previously mentioned are fulfilled while the third criterion is not, as the distnce $L_{msd} \cong 2.0 \text{ mm}$, is much lower than the distance at which the anomaly should be as to be accepted as imperfection $1,8\sqrt{Dt_c} = 558 \text{ mm}$.

Fig. 4. The graphical processing of the wall thickness measurement results in the imperfection/defect area

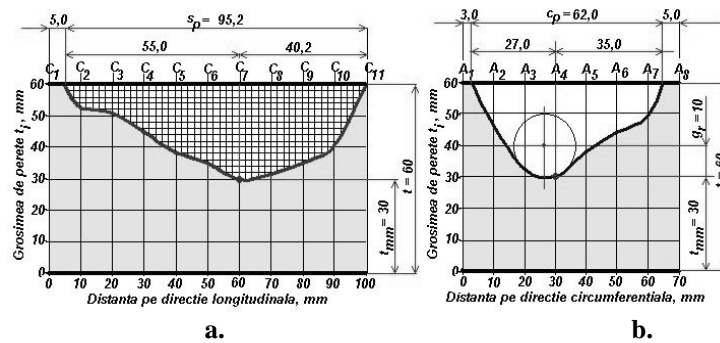
Fig. 5. The thickness critical profile – PCG – in the imperfection/defect area:
a. on longitudinal direction; b. on circumferential direction

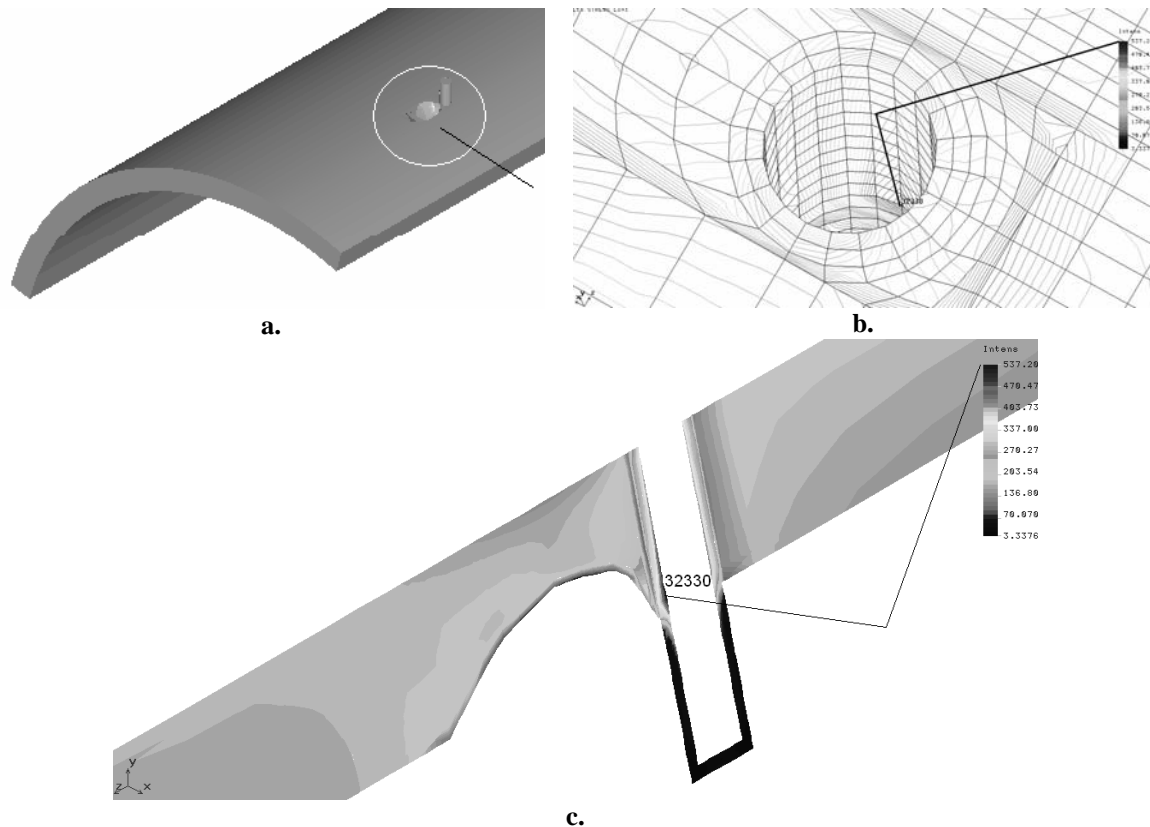
Moreover, as indicated by the tension distribution maps in Figure 6, the local values of the mechanical stresses are significantly larger than the allowable stress of the drum mantle material, at the operating temperature $t_m = 340^\circ\text{C}$, computed according to the *ISCIR PT C1-2003* and *PT C4/2-2003 Technical Prescriptions*, namely:

$$\max \sigma_{III}^{SLS} = 532,2 > \sigma_a = \min \left[\frac{R_{p0,2}^{340}}{1,5}; \frac{R_m^{20}}{2,4} \right] = \min \left[\frac{547}{1,5}; \frac{700}{2,4} \right] = 291,7 \text{ MPa}. \quad (4)$$

Consequently, following the level 3 assesement by numerical simulation FEM it results that anomaly type „ local metal loss”, detected on the outer cylindrical body of the steamboiler drum is qualified as being a **defect**. In this situation, for a safety drum operation it is necessary to remedy this defect.

Fig. 6. Graphical processing of the equivalent mechanical stresses in The Third Strength Theory T_τ corresponding to the *service limit state (SLS)* defined by parameters $[p_i + t_C^{340^\circ C}]$ assuming a *quasi-elliptical niche* model of the erosion: **a.** meshing of the FEM model using 12-15 solid finite elements distributed of the Barrel Shell thickness; **b.** FEM post-processing showing the stress iso-lines plot; **c.** contour plot of the stress over a longitudinal section through the niche and the XXVI nozzle, revealing a stress concentration at the 32330 node, on the inner surface of the $d_i=20$ mm recess, having magnitude $\max \sigma_{III} = 537.2 \times 10^6 \text{ N/m}^2$.

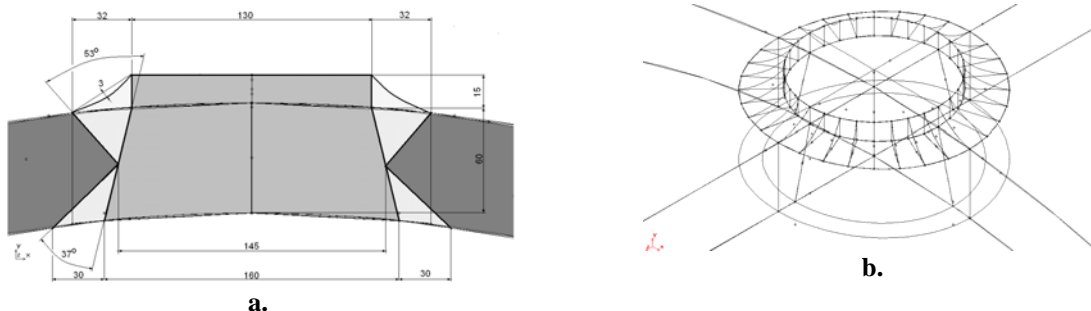
Fig. 7. Analysis model corresponding to repair by cutting out a defect enclosing cylindrical core with diameter $D = 145 \text{ mm}$, followed by welding of a thick metal patch of size $160 \times 130 \times (60+15) \text{ mm}$: **a.** Cross-section through a sector of the mantle showing the 2D geometry and size of the *cut-plug-weld* assembly; **b.** 3D view of the FEA solid element generating surfaces at the defect.

Considering the criteria stated above and the FEA results presented in Table 2, we conclude that the optimal repair solution corresponds to row 3.4 in Table 2, processed in figures 7, 8 and involves the following steps: 1) cutting out a cylindrical core of diameter $D = 145$ mm that encloses – and therefore removes – the metal loss defect; 2) welding of a thick metal *plug* with dimensions $160 \times 130 \times (60+15)$ mm, featuring a 15 mm high offset on its exterior surface and made of the same alloy as the drum mantle – AMMO 65 alloy; 3) connecting the plug (starting at the top of the offset) to the drum exterior surface through a concave fillet weld and grinding the exposed, concave surface of the weld to a depth of 3 mm.

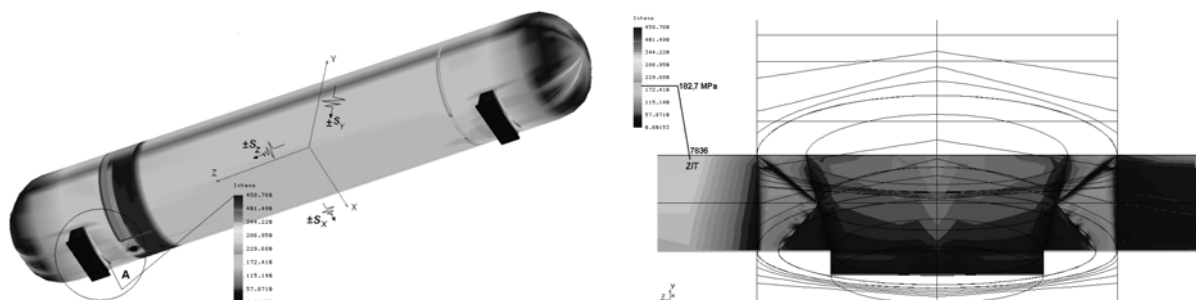
In the case of the repair solution processed in Figures 7 and 8, the maximum equivalent mechanical stresses according to The III-rd Strength Theory T_τ over the ZIT section of the repair panel comprising the *160x130x(60+15) plug-offset-welding ring-chamfer-ZIT structure* are much

smaller than the allowable stress of the mantle base material at the operating temperature $t_m = 340^\circ\text{C}$. This holds true for both limit states that were analyzed, *ULS* and *SLS* respectively, $\max\sigma_{III}^{ULS} = 182.7 < \sigma_a = 291.7 \text{ MPa}$, $\max\sigma_{III}^{SLS} = 172.14 < \sigma_a = 291.7 \text{ MPa}$. Satisfying these conditions is an express requirement of the ISCIR technical standard *PT CI-2003 (pct. 3.2.2.3 Methode de calcul lit. b) Resistenta)*, and therefore it reinforces and validates our choice of repair solution from the four possible candidates that were analyzed.

Fig. 8. Drum thermo-mechanical analysis by modeling the full *Barrel Shell-supports-repair panel* coupled system corresponding to the repair solution detailed in Figure 7, in the *ultimate limit state (ULS)* and subject to the $[1.0g_p + 1.0p_i^{11.5MPa} + 1.0t_i^{340^{\circ}C} + 1.0S_x + 0.3S_z + 0.3S_y]$ factorized grouping of load effects in this state: **a.** the full analysis model and the stress concentrator with magnitude $\max\sigma_{III} = 458.756 \text{ MPa}$ identified in the fix support in the fillet weld of the saddle gusset; **b.** detail of the ZIT section of the repair panel comprising the $160 \times 130 \times (60+15)$ *plug-outer offset-welding ring-chamfer-ZIT structure*, where the stress has the maximum value $\sigma_{III} = 182.7 \text{ MPa}$ at node 7836.
