Analysis of Helical Shaft Fracture during Exploitation of Rotary Screw Compressor

Case Study - Analysis of Helical Shaft Fracture during Exploitation of Rotary Screw Compressor

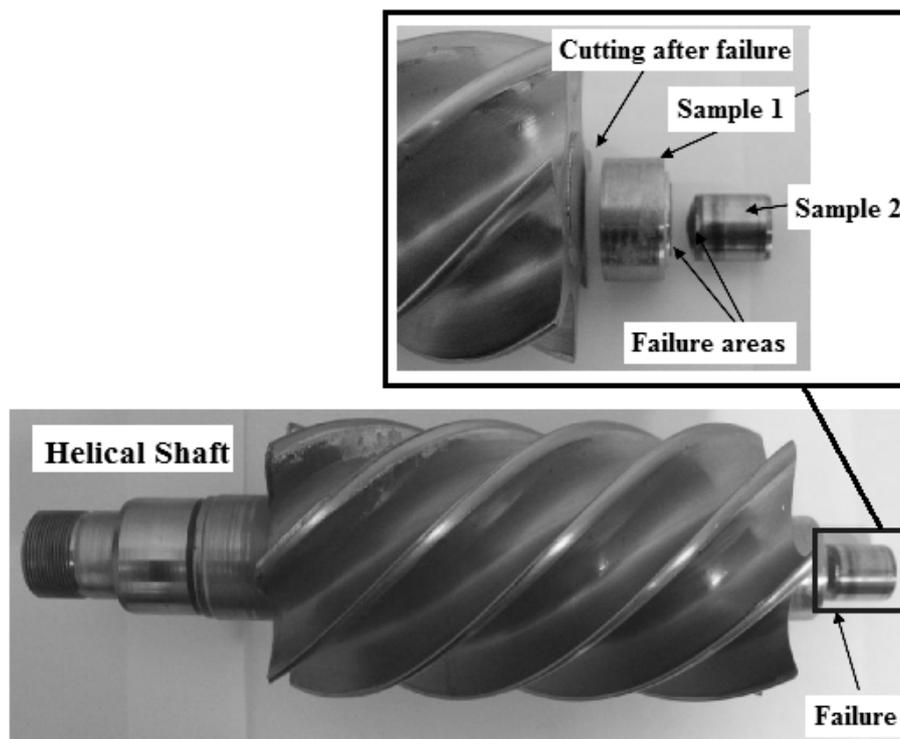
Fig. 3. The Helical Shaft fracture areas – sample used in analysis

The fracture of the part occurred in the minimal section area, at the end of the bearing mounted on that section. The visual and macroscopic with small magnifications examinations were performed after the bearing was removed and revealed the following aspects [9]:

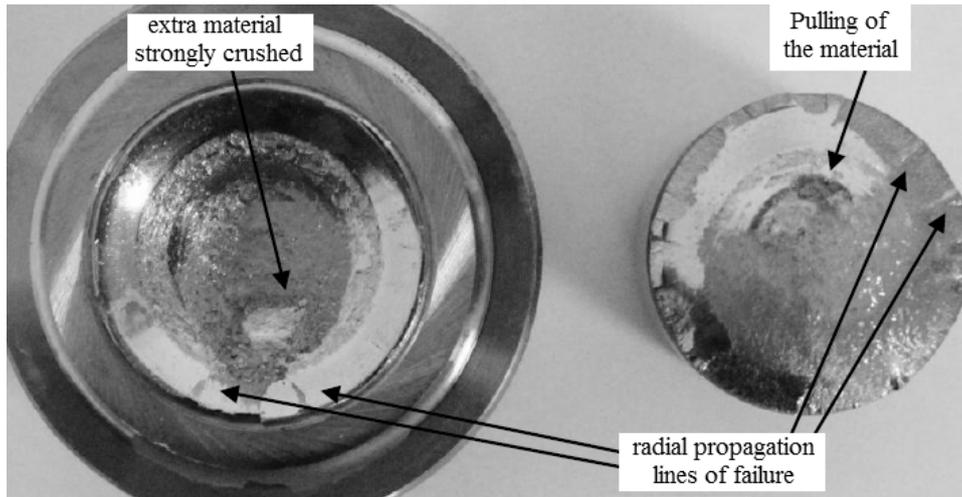
Fig. 4. Analysed samples: sample 1 – right, sample 2 – left

- the bearing removed from sample 1 did not show signs of abnormal behaviour during usage;
- the exterior surface of sample 1 (on generators) showed small abrasion areas, that probably formed during the installation of the bearing, but with no fractures visible to the naked eye, towards the fracture surface; these area will be the studied using the scanning electron microscope;
- the exterior surface of sample 2 (on generators) showed friction marks that were probably produced after the fracture occurred; there were no cracks visible to the naked eye;

- from a macroscopic point of view, the fracture surfaces are destroyed in proportion of 70% by calking due to the friction between them, after the occurrence of the fracture; there were no straining grooves and a specific rupture point could not be identified because of the advanced degradation state of the surfaces;
- on the fracture surface of sample 1 we could observe a material loss of macroscopic dimensions, that corresponds to a material excess on sample 2, strongly calked (see fig. 4); both areas will be examined at large magnifications using the electron microscope.

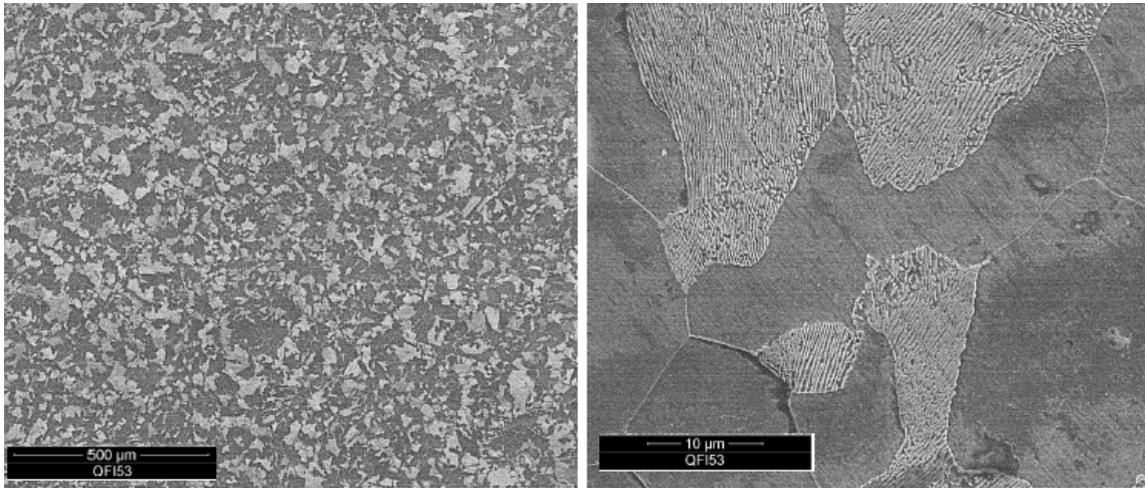
- The general aspect of the microstructure is normal for a carbon-steel that suffered normalized plastic deformation; the microstructure consists of ferrite and lamellar perlite grains, constituents found in equal proportions; the structure is extremely fine, with a grain size of score 6-7 according to ASTM E112 (see fig. 5);
- We could not observe non-metallic inclusions, especially silicates, nitrates, and sulphates, extremely fine and uniformly spread on the examined surfaces; the inclusion level was normal for steel under normal conditions;
- We could not observe signs of material overheating during the plastic deformation and thermal treatment procedures.

Fig. 5. Microstructure on sample 1, in two images (x200; x600), ferrite and perlite grains, extremely fine structure and high uniformity level.

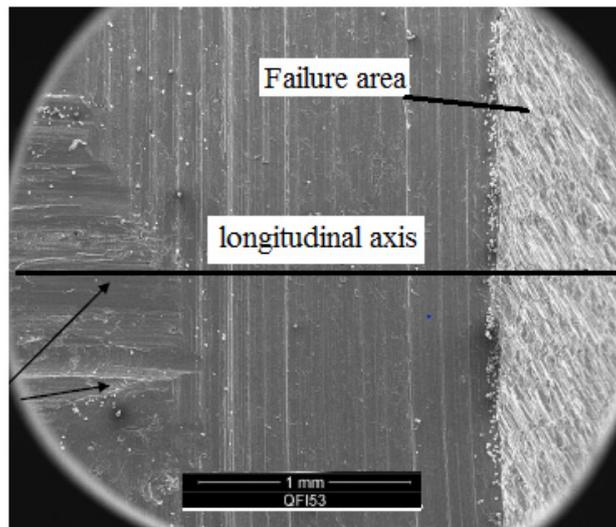
Fig. 6. Secondary electrons image (x100) of the exterior surface of sample 1. Superficial material deformations at about 2 mm from the fracture surface.

The small geometric irregularities observed on the exterior surface of sample 1 (during the macroscopic analysis) were examined using the scanning electron microscope, and we observed that the general aspect of the affected areas suggests a superficial deformation of the material that occurred, most likely, during the installation of the bearing, and no cracks on either the slightly deformed areas or on the spaces that separate them from the fracture surface, which shows that they did not contribute to the fracture [9].

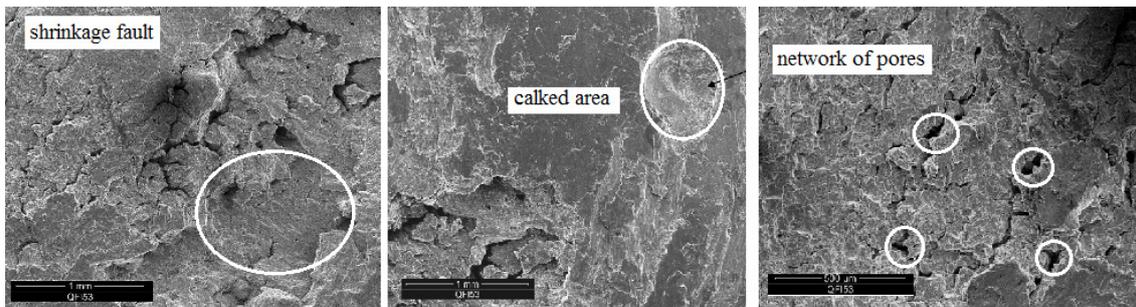
- the area marked on Figure 2 as a macroscopic fracture crater (a material loss of a couple of cubic milometers, on sample 1) turns out to be, after examinations at high magnifications, a material defect, specifically a cavity; around this macroscopic defect we observed a multitude of such microscopic defects, some of them obstructed by material pressed immediately following the fracture (see Figure 7); we also noticed material micro volumes surrounded by contraction holes;

Fig. 5. Examining the fracture surfaces using the scanning electron microscope

- the deterioration level of the fracture surfaces was approximately 90%; even in areas where the macroscopic analysis revealed the presence of fracture craters, these turn out to be flat and deformed due to the friction between the two parts separated by the fracture; we cannot establish the ductile-fragile character of the fracture; the defect is positioned at approximated half a radius from the centre.

The defects are macro and microcavities, the biggest one measuring approximately 4x3x4 mm. Surrounding these macroscopic cavities we observed areas with contraction pores that form networks around the material microvolumes, thus favoring the formation of radial cracks as a result of operation strains. Even though the dimensions of the whole area of defects cannot be precisely estimated, because of the advanced stage of deterioration of the fracture surface, it is certain that the fracture started from these defects, and propagated rapidly towards the edges of the part. The radial propagation lines, macroscopically observed on both samples, support this idea.

Regarding the material defects described in this report, they probably come from the start ingot that presented a central cavity, thinned by the ulterior plastic deformation procedures. In these conditions, it is very likely that the analysed part may present other areas with such defects, but unaffected during exploitation due to their bigger width. In the analysed case, the fracture was favored by the presence of the defect in the minimal section of the part.
