Analysis of Deformations Caused by Corrosion of Metal Construction of Excavator Arm ERC 1400

The corrosion problem of metal constructions of mining machinery is a very complex one, because of the environmental conditions in which they work. The paper presents results of experimental research which aimed to identify the corrosion of main elements of the 1400 ERC excavator arm. Corrosion size was determined using Leptoskop type equipment that allowed determining the thickness of the oxide layers and painting also. In parallel with the results obtained in the experimental research was carried out also a FEM analysis to identify the stresses and deformations of steel construction. Results permit establishing lifetime reserve of welded metal construction of the excavator port ladder arm.

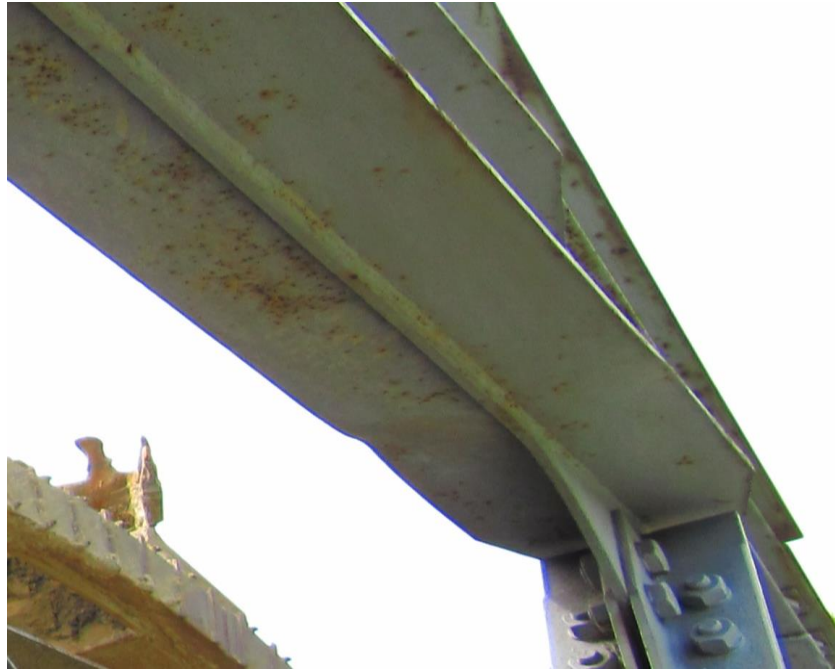
Fig. 3. Major deformation zone that appeared in the HL beam.

To make identification more accurate, measurement of the corrosion oxide layer and paint was done on one side and the other of metallic structure for each profile. From visual analysis of the steel structure of the excavator arm were observed maximum deformations of metal structure in the KL beam (fig. 3) and thus the research was focused on identifying the wear of beams linked to this beam, respectively LC, LD and LA beams.

Major deformation of HL beam may be explained by the fact that it is horizontally positioned and acid water could to corrode more but also because tensions arise here are the largest due to bucket wheel stress [8]. A general view of the HL beam and metallic profile shape I300 is shown in Figure 4, and experimental research results are presented in Table 1.

- HL beam presents the greatest redistribution of material, which makes it to be the most powerful stressed and thus for increasing the lifetime must be adopted technical solutions which allows increasing rigidity of this element;

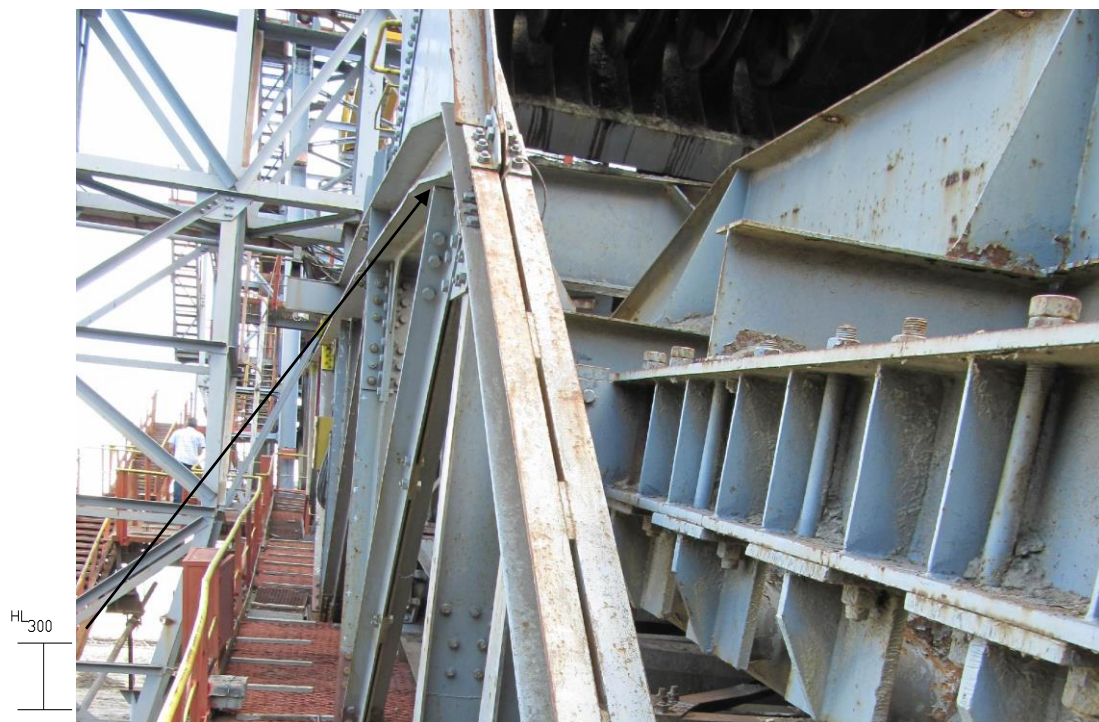
Fig. 4. Beam HL and its profile

Table 1. HL beam dimensions deduced from the measurements

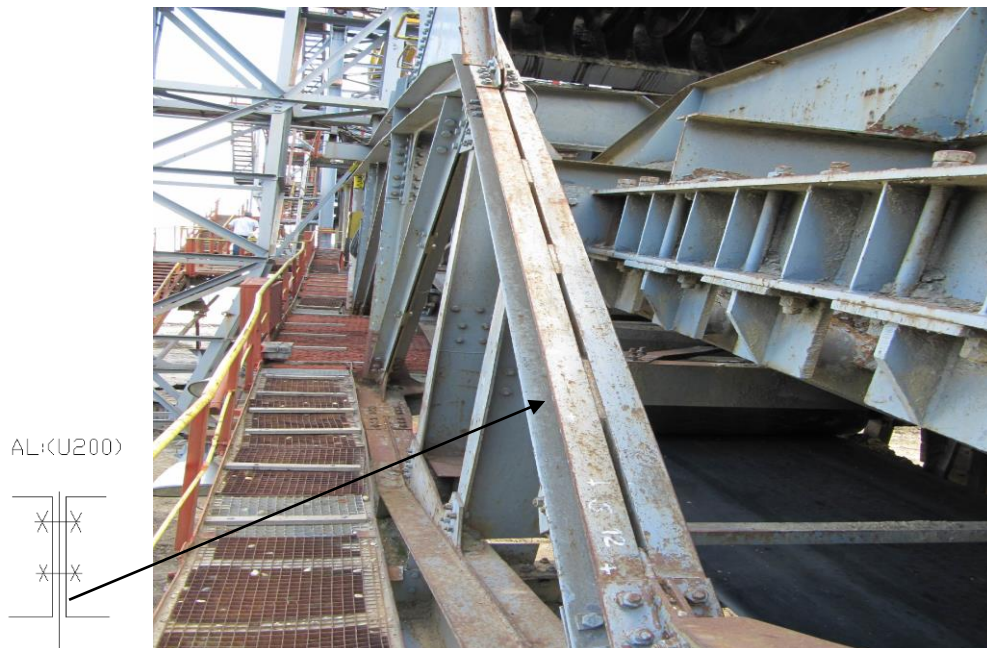
Fig. 5. Beam AL and its profile.

Table 2. AL beam dimensions deduced from the measurements

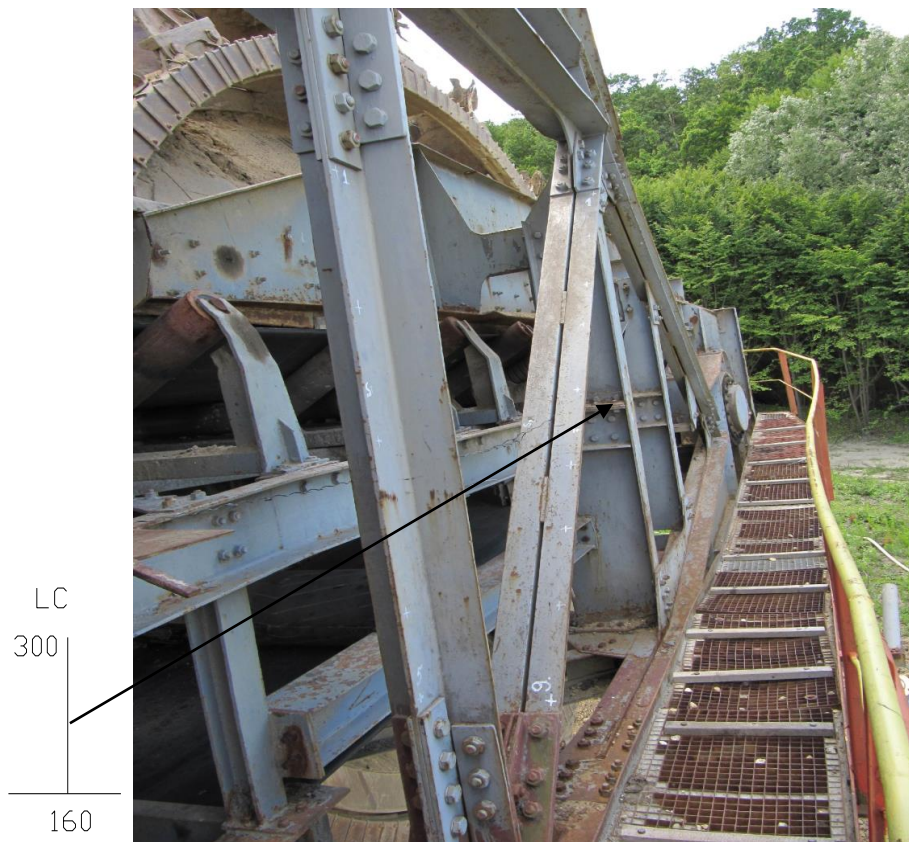
**Fig. 6.** Beam AL and its profile.

Table 3. LC beam dimensions deduced from the measurements

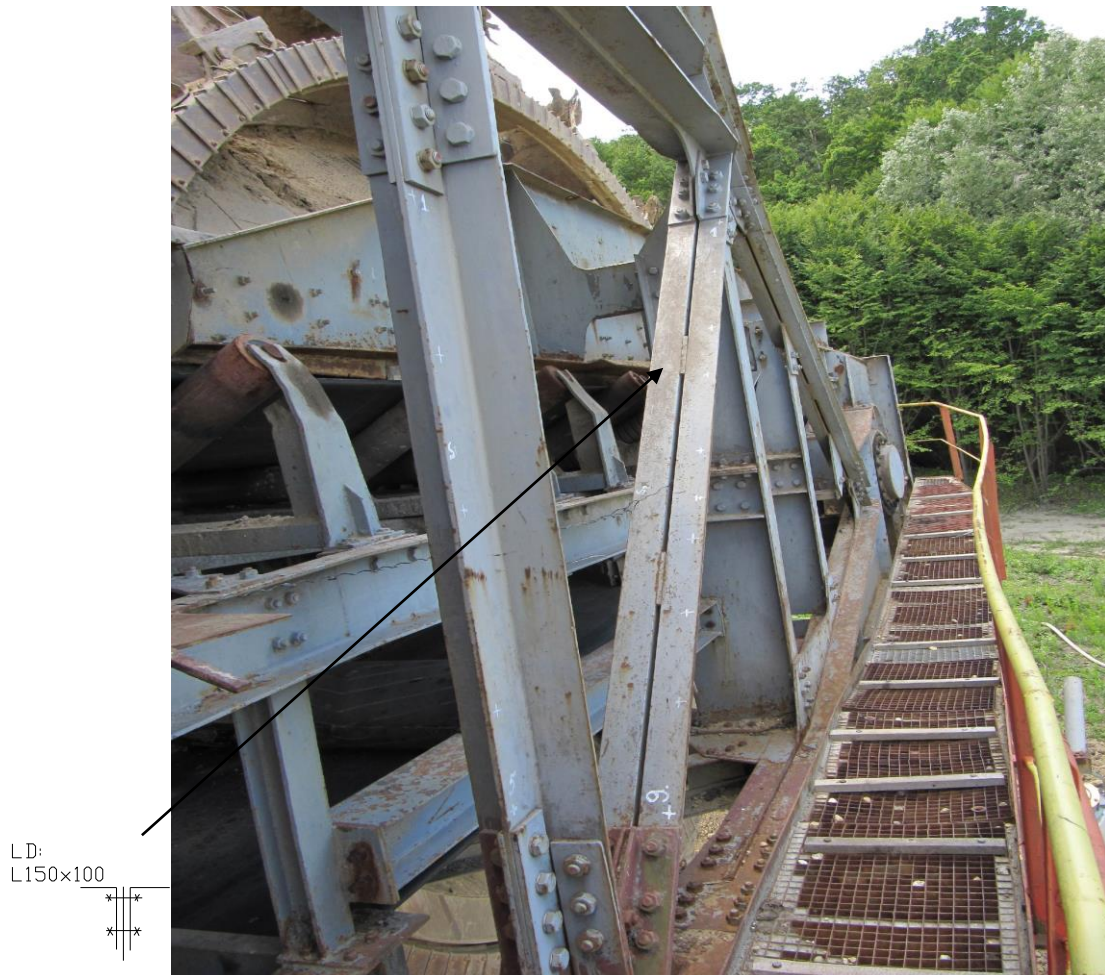
Fig. 7. Beam LD and its profile.

Table 4. LD beam dimensions deduced from the measurements

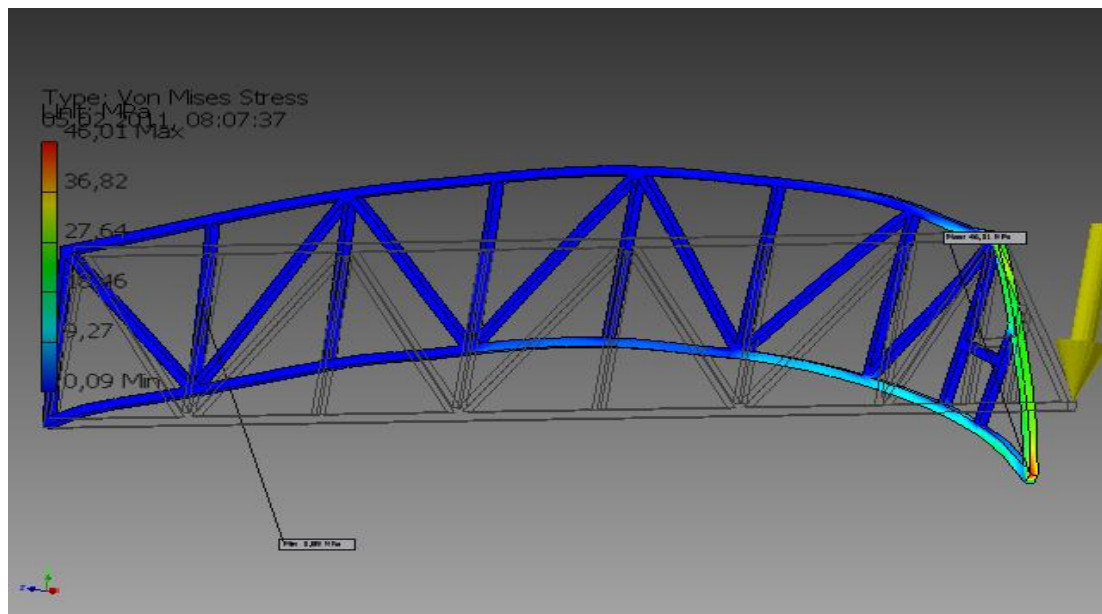
**Fig. 8.** Analysis of the stress of the excavator arm ERC 1400.

Analysis of stresses from the arm of the excavator status ERC 1400 is presented in Figure 8.

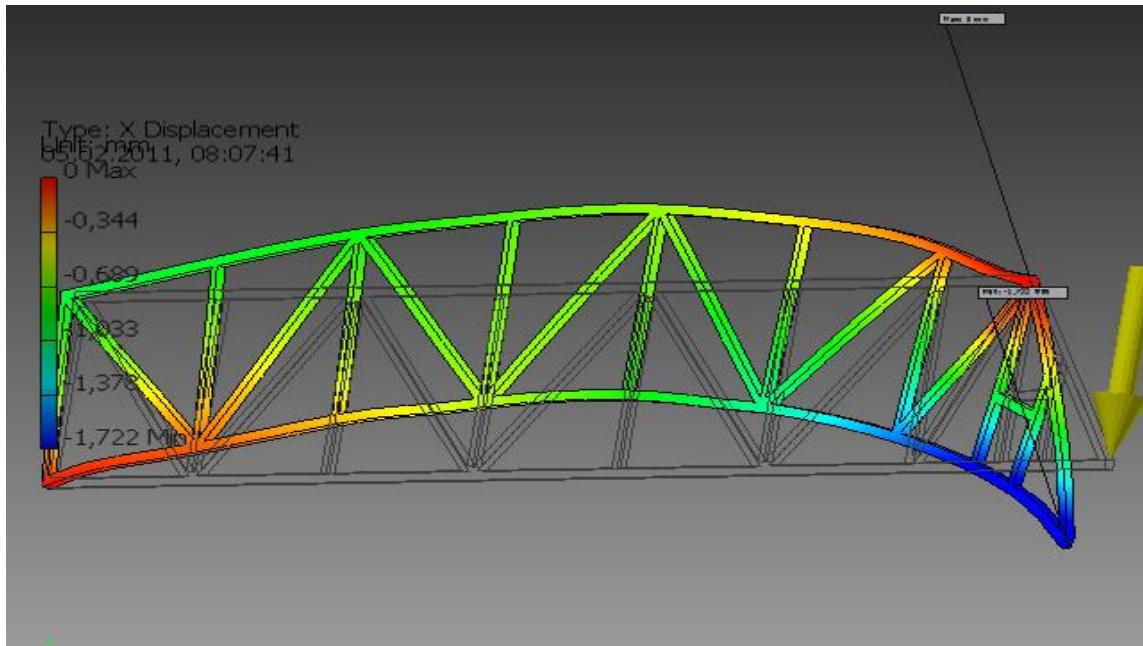
Fig. 9. Analysis of deformation state of the excavator arm ERC 1400

Analysis of the excavator arm 1400 ERC deformations status resulting from FEM analysis is presented in Figure 9.

- By using MEF is proven that deformation in reality is confirmed by the Finite Element Method analysis;
- Elements of the excavator arm having a horizontal arrangement are the most stressed implying a focus on operation and maintenance for these items;
