# The Diagnosis of Current Technical Status of Vertical Cylindrical Tanks from the BTX Technology Site

Florinel Lupu

In this paper it tries to make an exercise to support the claims above, by analyzing the technical status of tanks from a storage BTX park located in a refinery area, the interpretation of obtained results by examination in situ (diagnosis) and adoption of decisions accordingly.

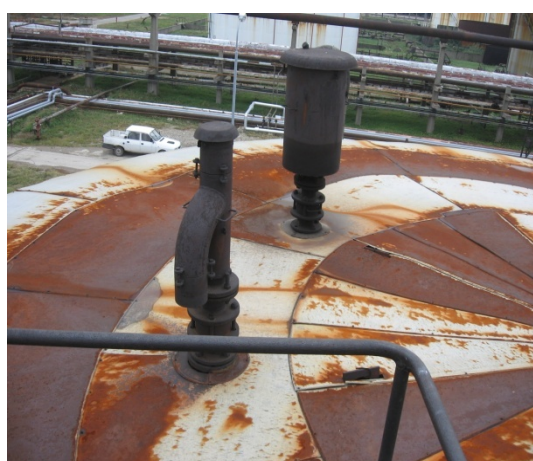
- 572A ... 572D tanks have both, the visible strains insulation of mantle and the cover.
- It noted the absence of insulation in places.
- The respiratory equipment on the tank cover is completely unworkable.

**Fig. 1.** The respiratory safety equipment, not working, completely rusty

- It is necessary to determine the flow of breath for tanks which store benzene;
- The respiratory equipment (arrester flame, mechanical breathing valve, hydraulic security valve) must be completely replaced;

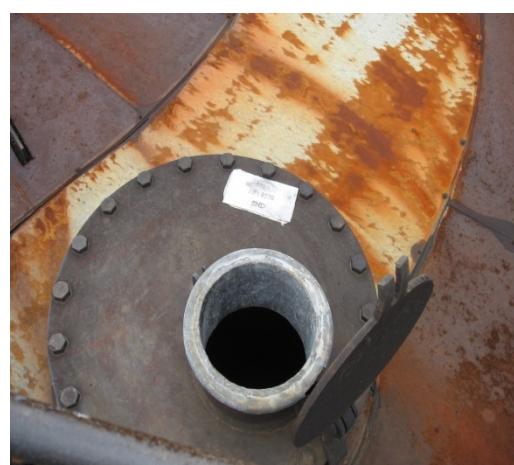
**Fig. 2.** The holes for taken samples, opened, in direct contact with the atmosphere

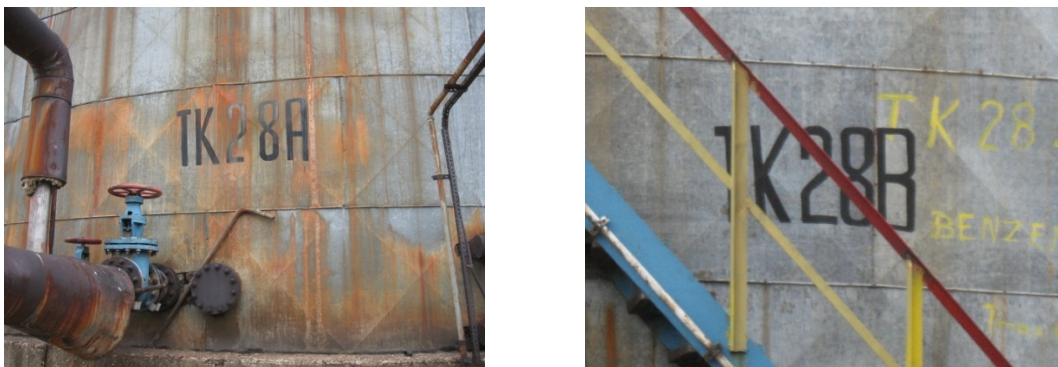
- There is an advanced corrosion in the sheet cover of the insulation which protects the shell of the tanks.
- There are untightnesses by the protection sheet of the insulation in the joints and in the manhole, which it produces the increased wetting of the insulation, leading to an advanced corrosion at the sheet of mantle.
- It is necessary to check the wall thickness of the mantle and to check deviations of circularity by manhole of the tank TK22B.

**Fig. 3.** TK28A, TK28B tanks location

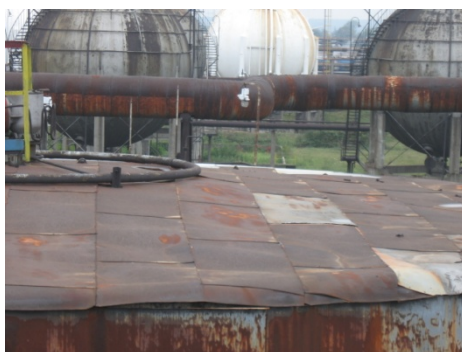
- There is an advanced state of corrosion of protection sheet for mineral wool.
- The insulation and the protection sheet are partially destroyed by connecting technological pipelines of tanks.
- The respiratory safety equipment is functional, but the hole for samples taken is situated in the open position, in direct contact with the atmospheric environment.
- There are permanent vapor emissions of stored products in the atmosphere.
- There is an imminent danger of self-ignition of the vapors and tank gets fire.

**Fig. 4.** The TK28A, TK28B tanks physical status

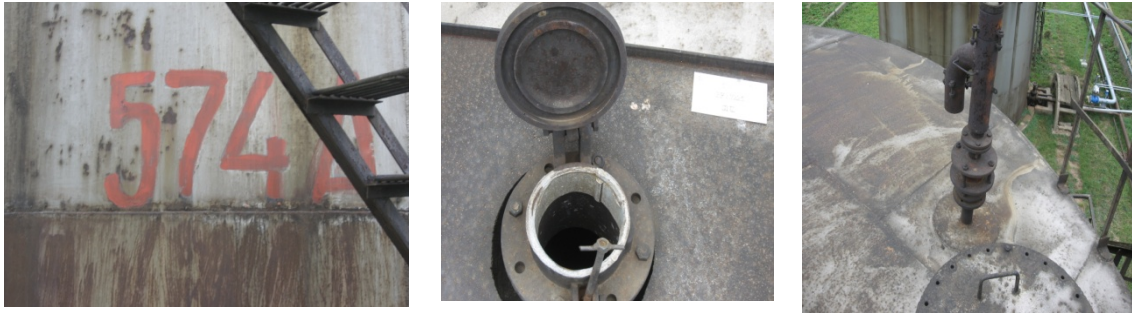
- 574A ... 574D tanks, which store toluene, are tanks without heat insulation, each with security respiratory system provided, outdated, unworkable, and the vapor emissions are directly discharged into the atmosphere by keeping the holes for samples taken in the open position.

**Fig. 5.** The 574A tank, having the respiratory equipment outdated and unworkable, with the discharge of emissions into the atmosphere through the manhole

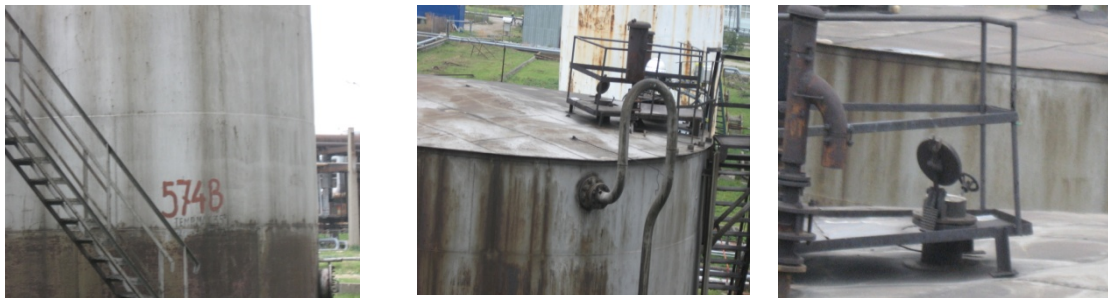
**Fig. 6.** The 574B tank, having the respiratory equipment outdated and unworkable, with the discharge of emissions into the atmosphere through the manhole

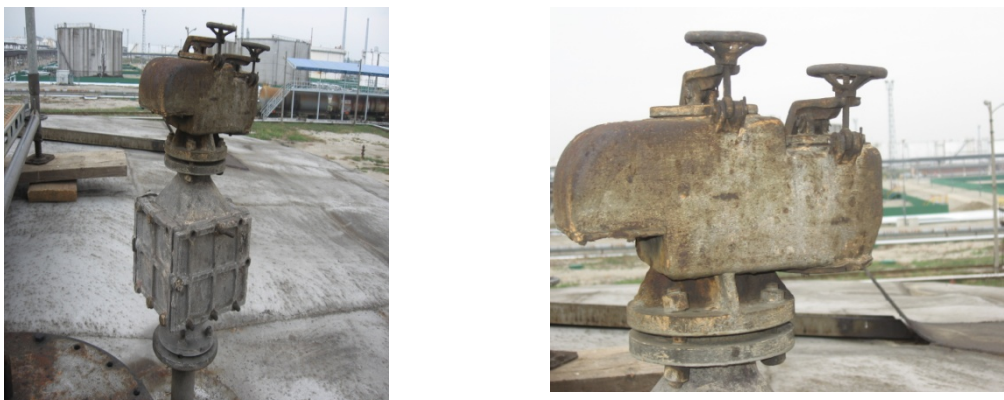
**Fig. 8.** The 587 tank, provided with a safety respiratory equipment outdated and unworkable, with arrester flame and mechanical breathing valve

- There is a total unfunctionality in terms of the equipment. The respiratory safety equipment is outdated, physically and morally worn;
- Currently, the tank works with the ventilation holes opened, allowing the vapor emissions of stored product, which it leads to security and safety in working almost nonexistent;
- In addition continues pollution of the atmosphere, there is a real danger of the tank get fire;
- It notices an advanced corrosion phenomenon at the bottom-mantle junction;

- It recommends the examination of assemblage possibilities for safety valves with flap (only in terms of overpressure) on the cover of tanks;
- It requires an appropriate respiratory safety equipment for every each tank (replacing the existing one, which is fully unoperational, physically and morally worn);
- It requires to adopt an adequate breathing equipment for the next period of working;
- For full security and minimize the risk of cracking at basic ring material, and pollution of the soil with the product, should be removing from service the tank 587, until the completion of the tightness and metal wall thickness checks.

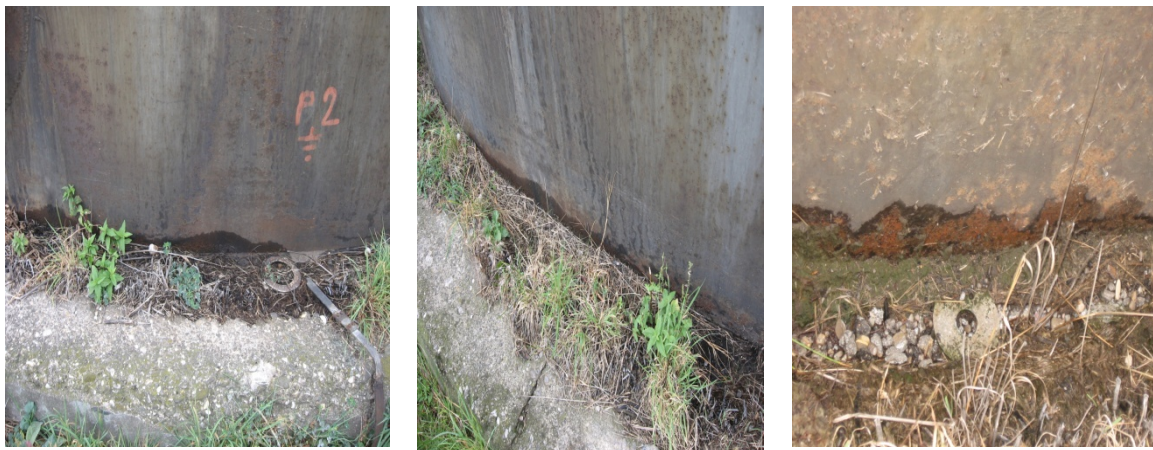
**Fig. 9.** The tank 587 presents an advanced corrosion at the bottom-mantle junction

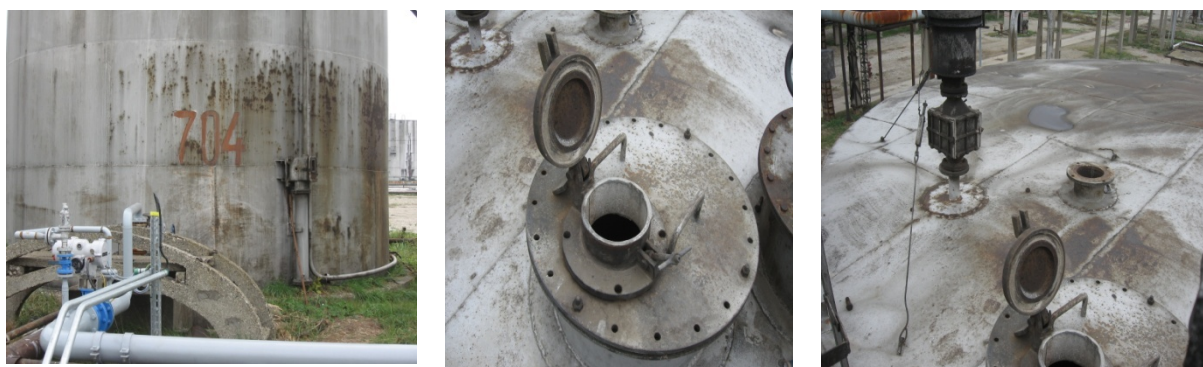
- There is a total unfunctionality in terms of safety respiratory equipment;
- Currently the tank works with ventilation holes opened, causing vapor emissions of stored product into the atmosphere, leading to very low safe operating and to the imminent possibility of the tank get fire.

**Fig. 10.** The tank 704, equipped with a safety respiratory system outdated and inoperative, having the holes for samples taken and for light opened
