An Assessment of the Severity of a Metal Loss Defect Detected on the Steam Boiler Drum of a Thermoelectric Power Plant and the Development of a Repair Technology

Gheorghe Dumitru, Gheorghe Zecheru

Universitatea Petrol – Gaze din Ploiești, Bd. București, 39, Ploiești
e-mail: dgheorghe@upg-ploiesti.ro, gzecheru@upg-ploiesti.ro

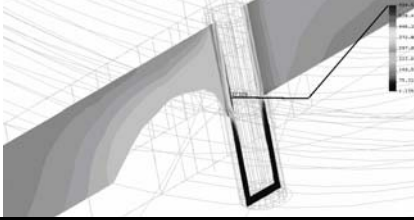
594.6
4	Quasi-elliptical niche identified in situ according to the photo mappings and mold geometry

Consequently, following the level 3 assesement by numerical simulation FEM it results that anomaly type „ local metal loss”, detected on the outer cylindrical body of the steamboiler drum is qualified as being a **defect**. In this situation, for a safety drum operation it is necessary to remedy this defect.
