Analysis of Deformations Caused by Corrosion of Metal Construction of Excavator Arm ERC 1400

The corrosion problem of metal constructions of mining machinery is a very complex one, because of the environmental conditions in which they work. The paper presents results of experimental research which aimed to identify the corrosion of main elements of the 1400 ERC excavator arm. Corrosion size was determined using Leptoskop type equipment that allowed determining the thickness of the oxide layers and painting also. In parallel with the results obtained in the experimental research was carried out also a FEM analysis to identify the stresses and deformations of steel construction. Results permit establishing lifetime reserve of welded metal construction of the excavator port ladder arm.

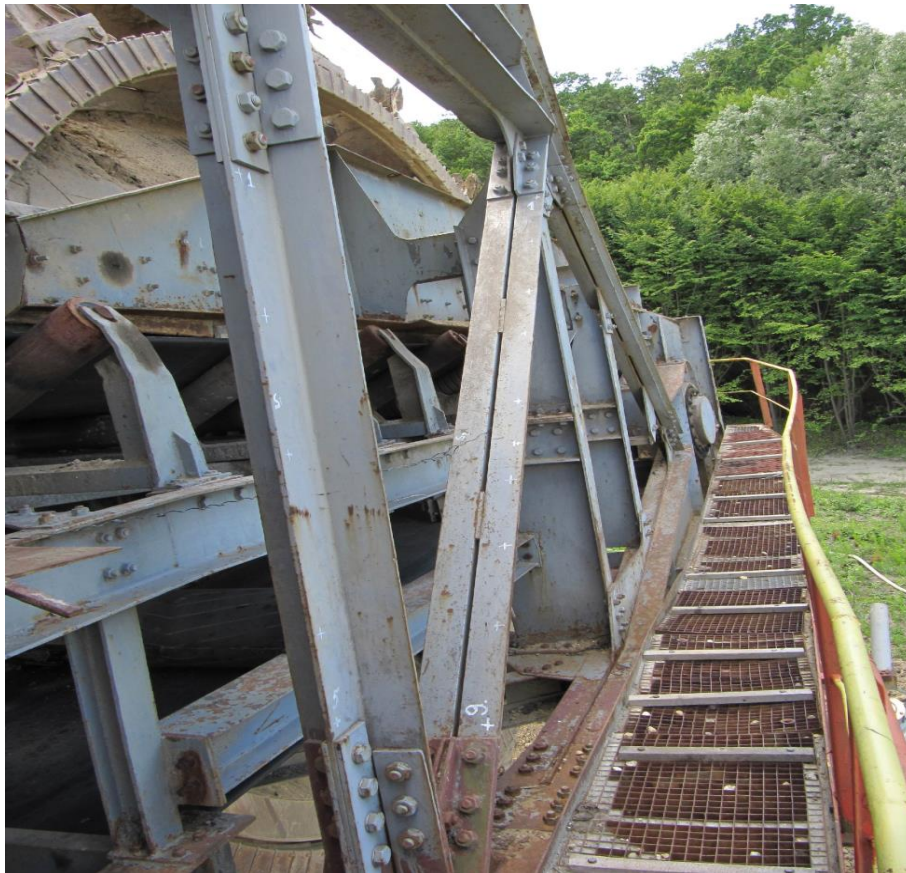
Fig. 1. Excavator arm.

For equipment from quarries pit lignite, the most stressed part is infrastructure which includes arm shedder excavator (fig. 1), subassembly where appeared most failures due to nonconformities whose causes is related to technology and material, and also the use of equipment in a quite corrosive environment. Arm as supporting the bucket rotor subassembly

has the strongest demand during the operation and once operational deficiencies occur, they lead inevitably to decrease projected lifetime if not proceed to repair welded structure.

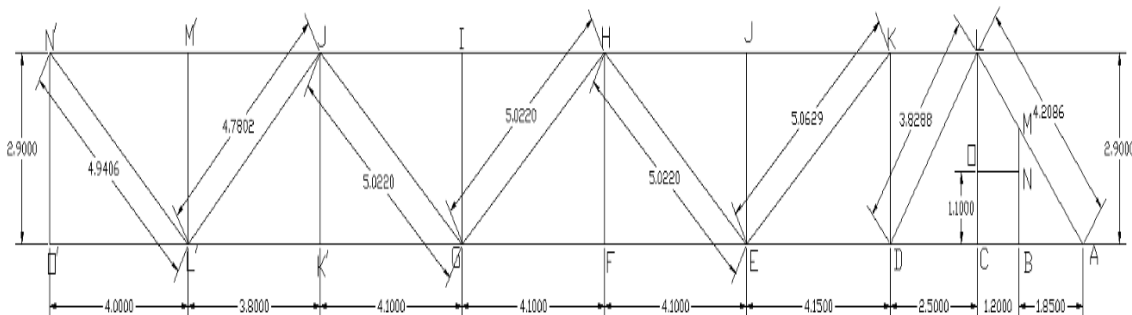
Fig. 2. Excavator arm dimensions.

In these circumstances researches followed oxide film thickness and paint determination on metal construction elements, thus can be established the effective thickness of rolled steel elements of the steel structure. To achieve research initially have been identified the size of the excavator arm metallic structure elements and on these elements were positioned analysis points located at a distance of about 250 mm (fig. 2).
