Digital Image Correlation Investigations on the Interface Failure of a Sandwich Composite

Matei Constantin Miron, Dan Mihai Constantinescu

Abstract

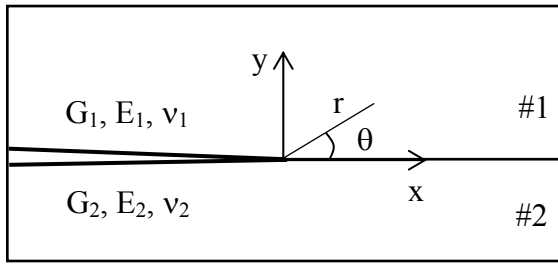
Two linear elastic and isotropic materials are divided by an interface and a crack along it (Fig. 1). The materials are #1 (top) and #2 (bottom) having at the crack tip a cartesian (x,y) system or a polar one (r, θ) with different elastic constants $G_i, E_i, \nu_i, (i = 1,2)$ as: transversal modulus of elasticity, longitudinal modulus of elasticity, respectively Poisson's ratio. It is to be notated $k_i = 3 - 4\nu_i$ for state of plane strain and $k_i = (3 - \nu_i)/(1 + \nu_i)$ for state of plane stress.

Fig. 1. Notation of the interface constants

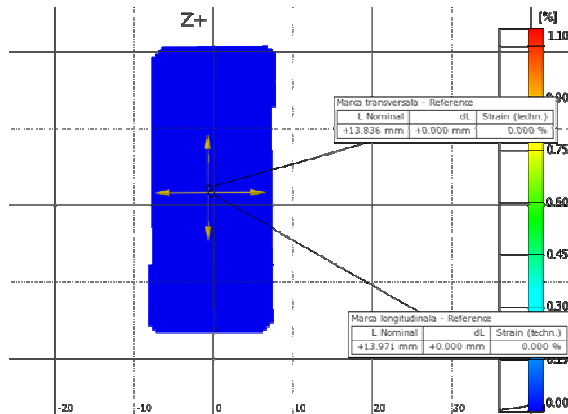
Specimens of about 20 mm width and 1.5 mm thickness were tested. Five tests were done and each time, in order to calculate also Poisson's ratio, two virtual strain gages of 15 mm were emulated in the middle of the specimen: one longitudinal and the other transversal (Fig. 2). In figure 3 longitudinal strains before failure are shown in the skin as being localized around glass fibres which break. Initial failure of the mat fibres start at about 60 MPa and nonlinearities in the stress-strain diagram appear. The obtained results for the five tests are given in table 1.

Fig. 2. Skin with virtual strain gages used in ARAMIS

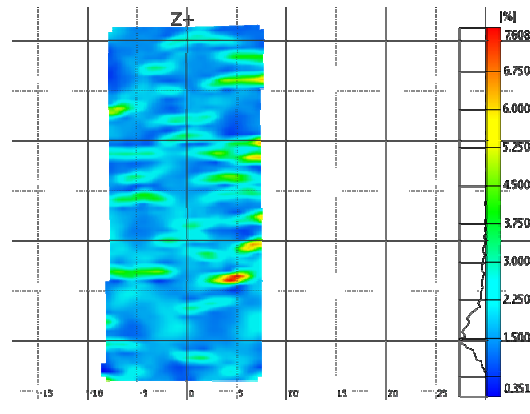
Fig. 3. Longitudinal strains in the skin before failure

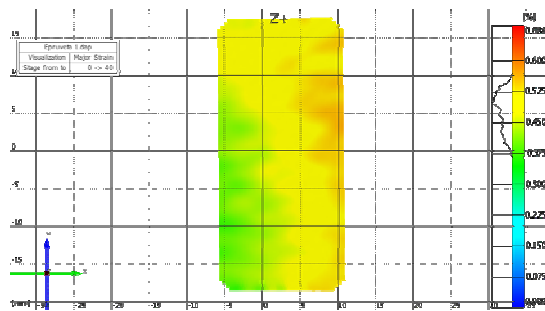
Same procedure as before was used for the tensile testing of the polyurethane core with a density of 200 kg/m³. The response of the material is nonlinear and more ductile after a stress of 3.5 MPa is reached, and failure is produced around 5.9 MPa. The level of strains is quite low, and no specific indication is noticed before breaking. Just as an example for one test, the longitudinal strains are shown in the linear elastic domain at a stress of 0.9 MPa (Fig. 4), and in the last frame before failure at 5.98 MPa (Fig. 5).

Fig. 4. Longitudinal strains at 0.9 MPa

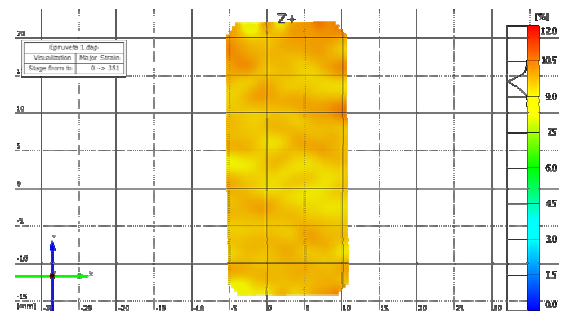
Fig. 5. Longitudinal strains at 5.98 MPa

Results of two tests are given hereby, in table 2. As seen in figure 5, before the failure of the specimen no indication of the local strain increase in a specific section was noticed.

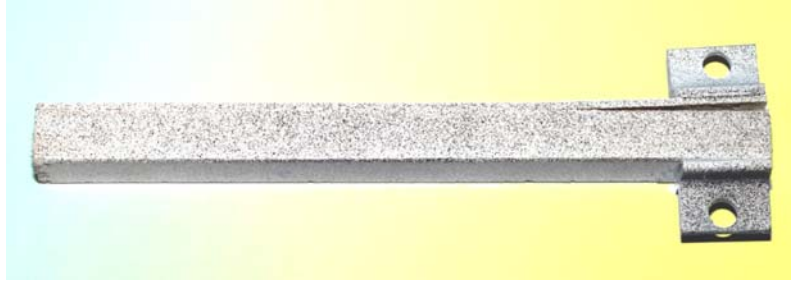
The sandwich has the skins with average thicknesses: top of 1.73 mm, and bottom of 1.98 mm. The polyurethane core is about 12.5 mm. An initial delamination of about 45 mm is produced by introducing a non-adherent film at one of the interfaces. In order to be able to load the specimen two special tabs of 25 mm are glued on the top and bottom of the specimen towards the end with the insert. The whole specimen is painted in white and black speckle dots in order to be able to use DIC. The specimen prepared for testing is shown in figure 6.

Fig. 6. Sandwich composite specimen prepared for testing

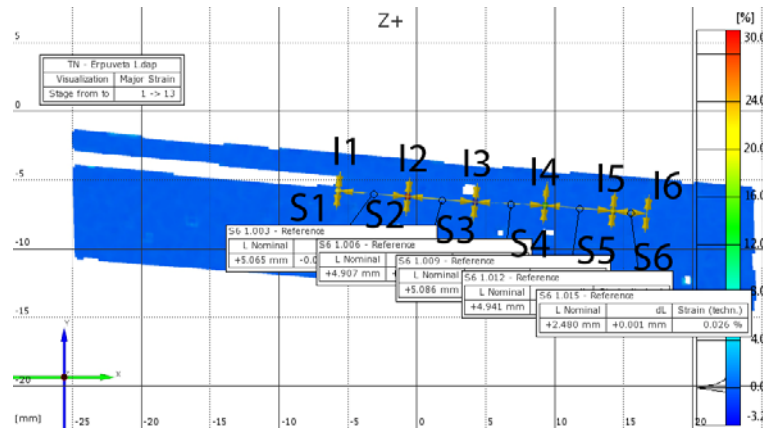
the top tip on the lower part of the skin and the bottom tip on the core; *S* strain gage is positioned beneath the *I* strain gage having its top tip common with the bottom *I*-tip and the bottom tip in a lower position in the core (Fig. 7). We are going to call: the *I* strain gage as being interface, and the *S* strain gage as being core.

Fig. 7. Position of virtual strain gages along the interface for test 1

Strain gages *I* and *S* are in the same location for one monitored point, that is we measure the strains at the interface and in the core. For test 1 there are five positions which are monitored during the failure of the interface crack. In table 4 the initial monitored point is at the tip of the initial delamination. Only strains measured with the *I* gages are given.

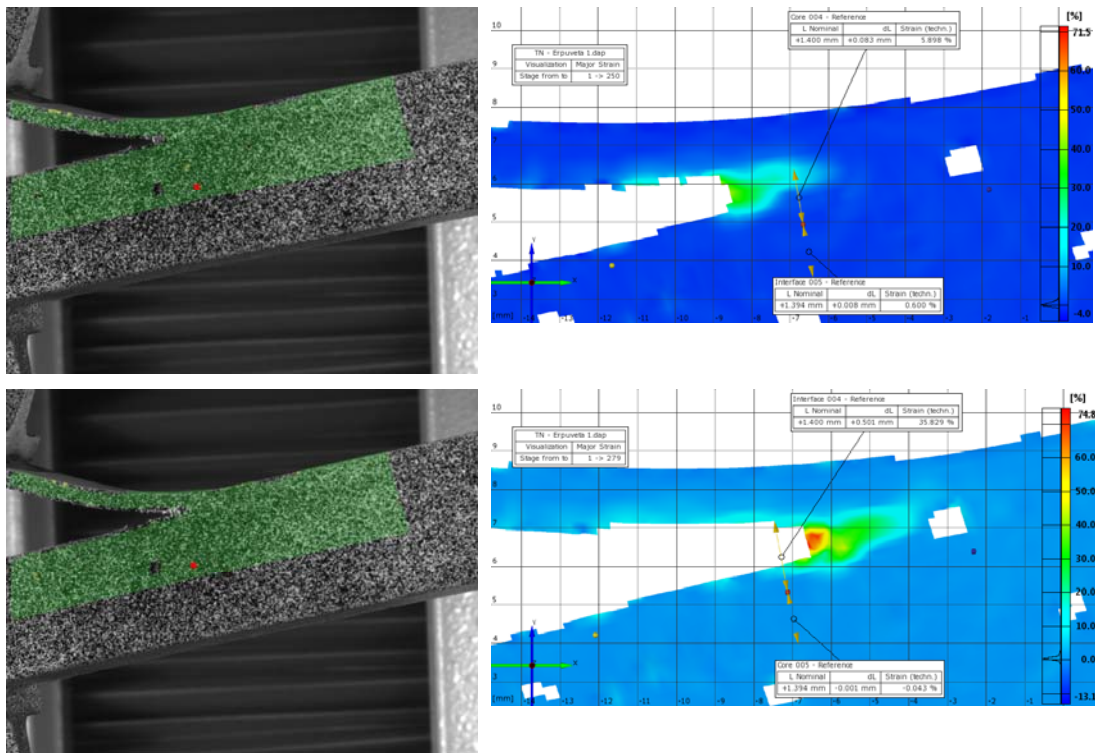
Fig. 8. Picture of the specimen from test 1 and DIC analyses before and after the second crack propagation

For test 1 are shown the measurements done before and after the second crack propagation (Fig. 8). The initial and final damage parameters (show in table 4) are quantified in corresponding frames by using DIC.

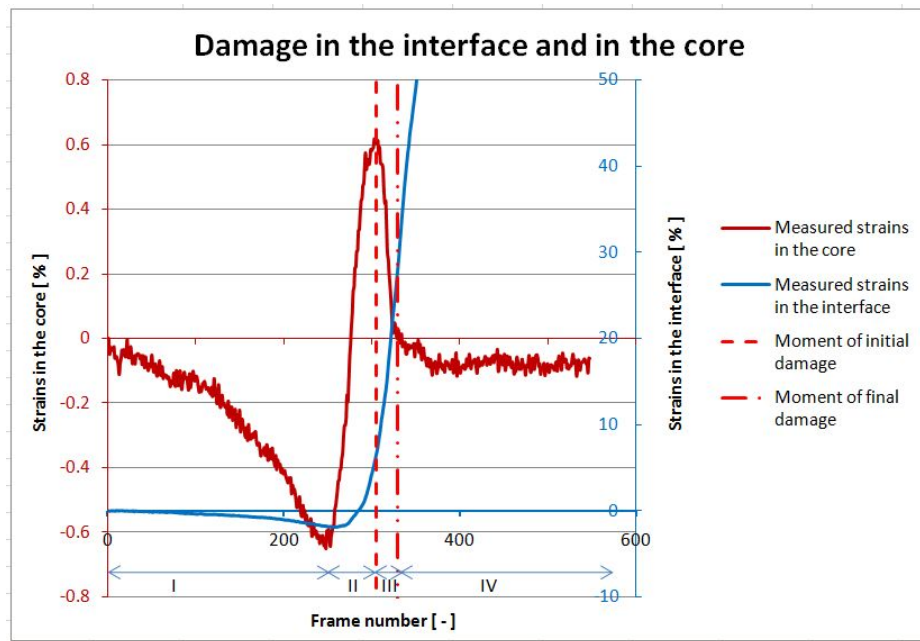
In figure 9 is presented the typical variation of strains in the interface in a monitored point which is initially further away from the tip of the initial delamination [14]. For the second crack propagation the damage processes are produced in between frames 305 and 350 (Table 4). There are four distinctive domains of strain variations which are obtained:

- *domain I* in which the interface and the core are in compression due to the loading of the specimen; meanwhile the crack propagates in a stable manner towards the monitored point;
- *domain II* in which both interface and core are loaded in tension; the tip of the crack reaches the monitored point;
- *domain III* while damage is produced with increasing strains in the interface and relaxation of strains in the core;
- *domain IV* registers the strains in the material of the core; meanwhile the crack exceeds the point of measurement and, although strains in interface still increase there is no physical significance for such a trend as there is no material left at the interface.

Fig. 9. Variation of strains at the interface and in the core in a monitored point while damage is produced

After the initiation of damage in the interface the material around the tip of the crack (core) relaxes and strains diminish; meanwhile strains in interface increase significantly. The final (complete) damage of the interface zone is attained when the material of the core relaxes completely and strains remain mostly constant, as seen in figure 9 (domain IV).

Four main domains are encountered and comments in figure 9 are done concerning their characteristics. Mixed modes are present at the interface and their analyses is going to be done elsewhere. Strain localization phenomena will be discussed in more detail by enlarging the analyses on successive failures at the interface during the same test. All these phenomena are essentially nonlinear and the proposed procedure gives a more realistic perspective on the evaluation of interlaminar damage.
